High Water Mark Field Form

DATE: 11/4/2012 STORM: Sandy PARTY: CAS/KAC

SITE NAME: HWM-NJ-MON-212 LATITUDE (DD to 6 places): 40.42251
(Site Name Format: HWM-SS-COU-###, where SS = state, COU = county, ### = site number)

SITE DESCRIPTION: 2 Benton Ave LONGITUDE (DD to 6 places): 74.05932

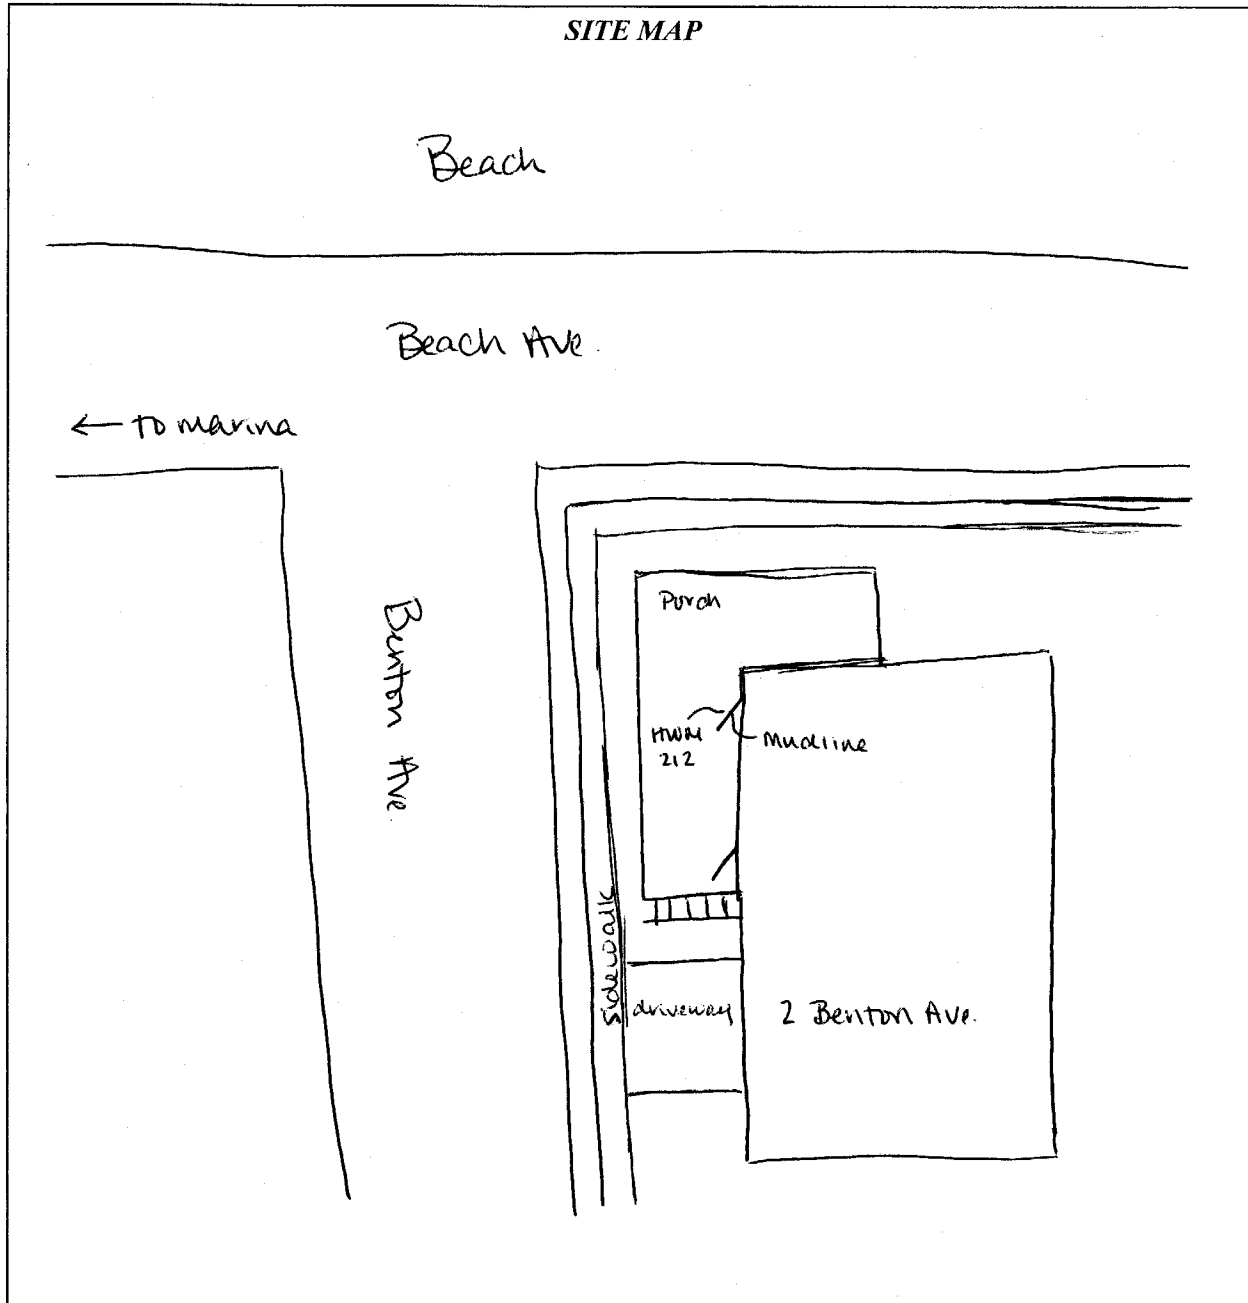
HWM Description: mudline on door to northwest ^{door} entrance to porch
of residence at 2 Benton Ave. Stairs to ^{north end of} porch are ~20ft to Beach Ave.
Marked w/ ^{HWM} ~~Survey~~ marker to left of door.
